Manhole Inspection Summary

Manhole # S21WW1057MH

Insp Date: **5/8/07 1:04 PM**

Location Address: **15 ENGLEWOOD RD**

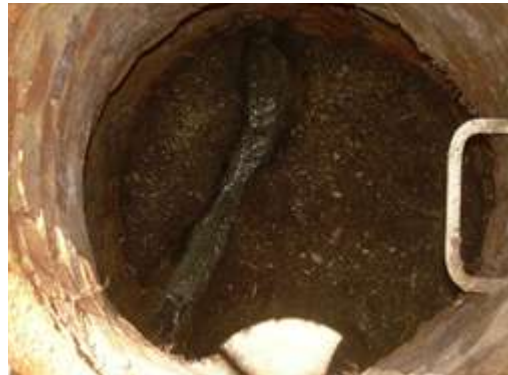
Top View

Bench debris.

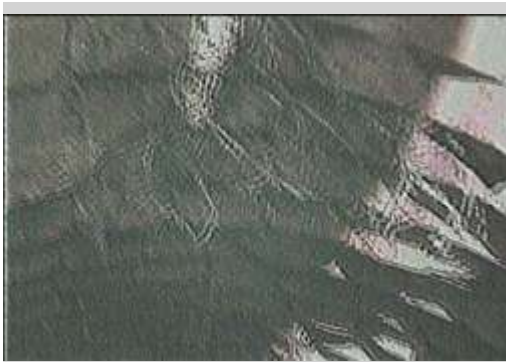
Defect

Adjustment, Corbel and Barrel deterioration, root intrusion and infiltration.

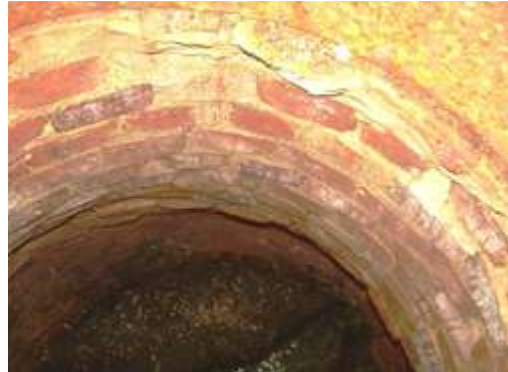
Defect

Adjustment deterioration and infiltration.
Barrel root intrusion and infiltration.

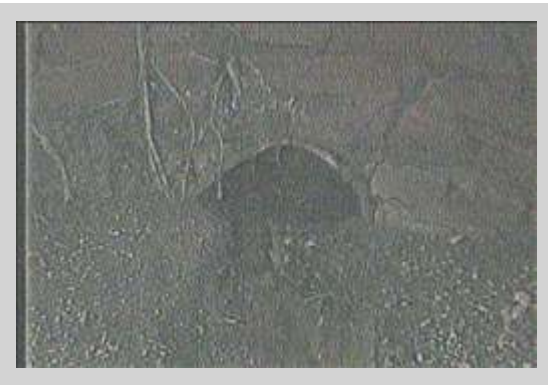
8 in. Circular Gravity Sewer Pipe Out @ 12 O'Clock

Barrel deterioration, root intrusion and infiltration. Channel root intrusion.

Deposits: ☐ None ☒ **Mud** ☐ Sludge ☒ **Debris** ☐ Grease

Silt Depth: **0.5** (in.) Deposits Extent: **Light**

Infiltration: **Evidence** Pipe Seal Cond: **Cracked**
